Spectroscopic Analysis of Perfluoropolyether Lubricant Degradation During Boundary Lubrication

William R. Jones, Jr.
Lewis Research Center
Cleveland, Ohio

Prepared for the
1997 Tribology Conference
cosponsored by the Society of Tribologists and Lubrication Engineers
and the American Society of Mechanical Engineers
London, United Kingdom, September 8–12, 1997

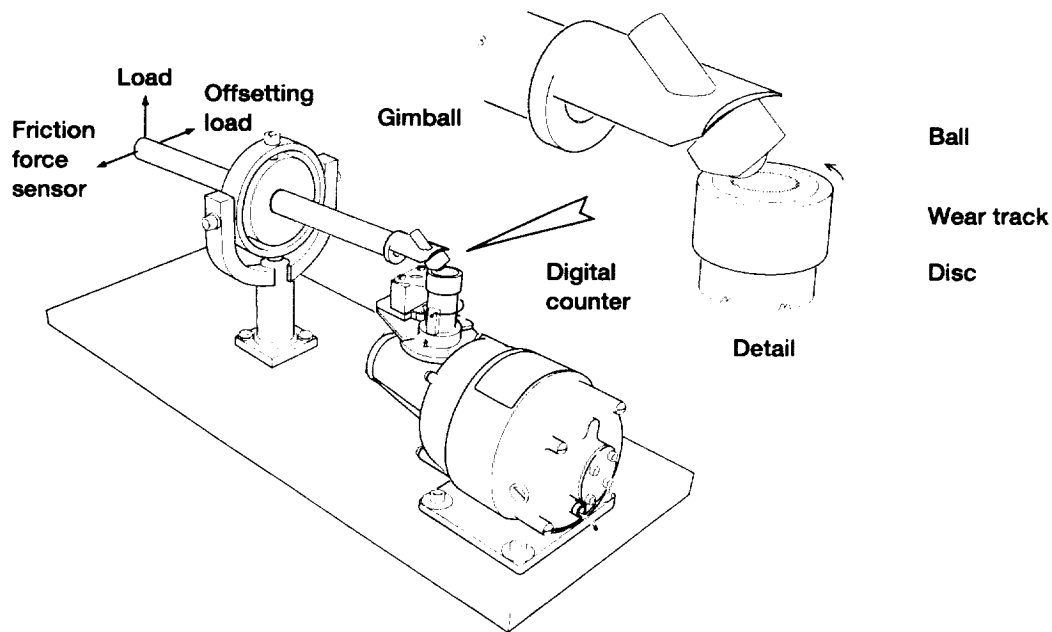
Figure 1.—Fixed ball-on-disc tribometer.

Tribological testing of each disc was performed on a fixed-ball-on-disc tribometer (16) shown in Figure 1. All tests were performed using a relative sliding speed of 0.05 ms^{-1} and a 3-N normal load which generated an initial Hertzian contact stress of $\sim 0.7\text{ GPa}$. All tests were run at ambient temperatures ($\sim 25^\circ\text{C}$). The majority of the tests were run

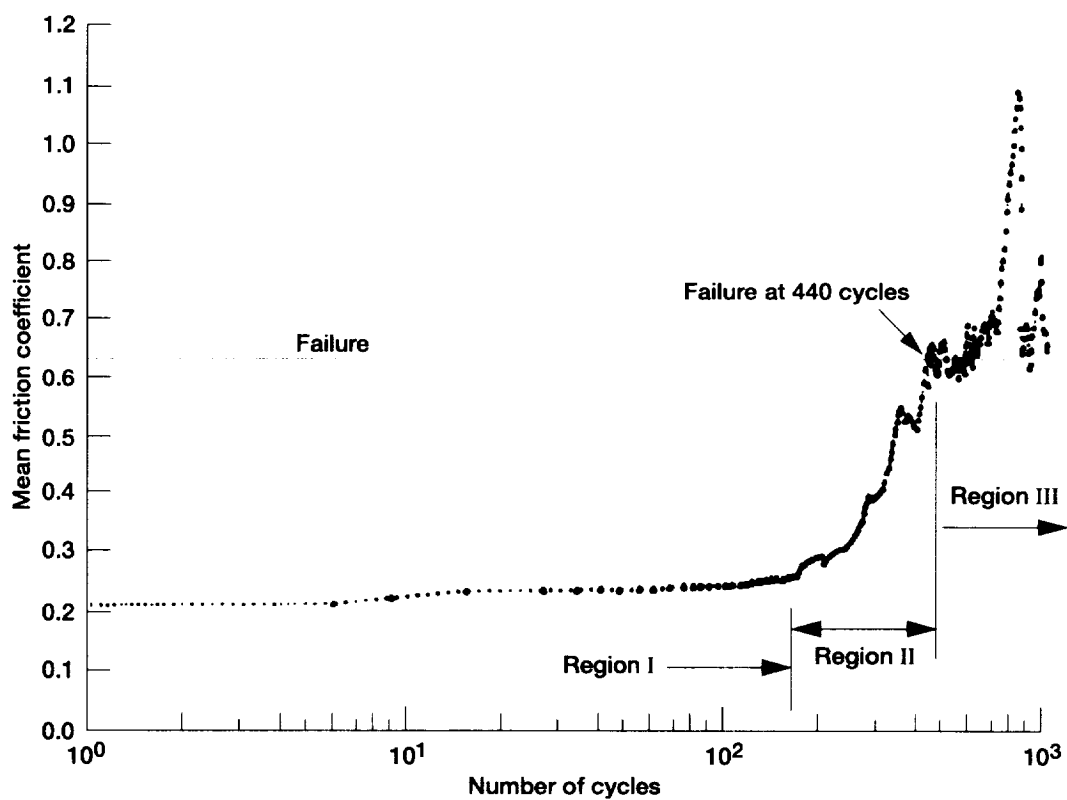
Figure 2.—Typical friction coefficient as a function of number of cycles for a 600 Å PFPE film.

Specimens were run on the ball-on-disc apparatus until one of three criteria were attained. These criteria correspond to different values of the mean friction coefficient and are referred to as Regions I, II and III. During Region I, the friction coefficient remains essentially constant at approximately 0.20 ± 0.06 . Region II represents a transition region which typically both begins and lasts several hundred cycles. In this region, the friction coefficient gradually increases from 0.2 to approximately 0.63. Region III represents total loss of lubrication function, as the friction coefficient is ≥ 0.63 . This corresponds to an unlubricated metal-metal contact (16). A typical friction trace as a function of number of cycles for a 600 Å PFPE film appears in Figure 2. Micrographs of typical wear tracks for each region appear in Figure 3.

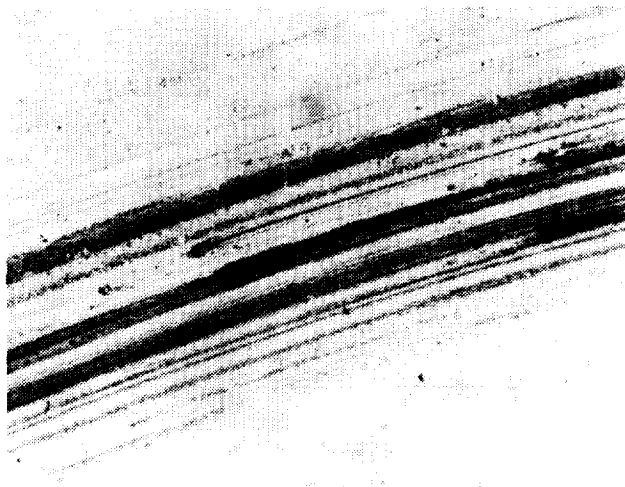
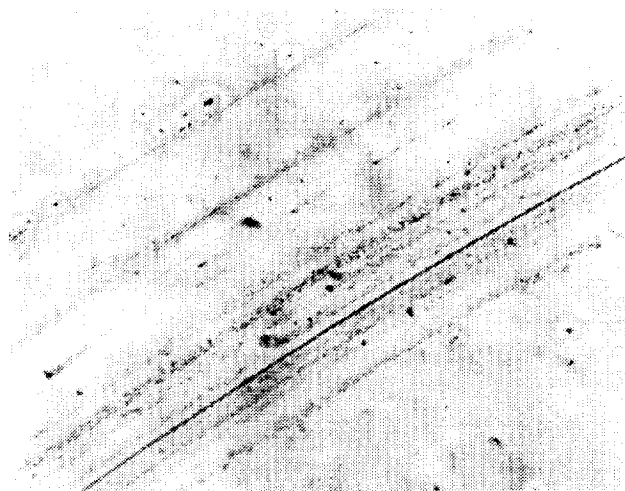
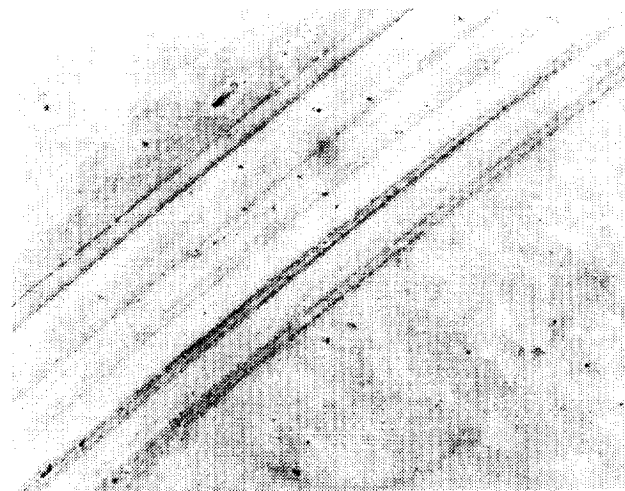
Region I

Region II

Region III

Figure 3.—Micrographs of the wear track for each of the regions labeled in the friction trace (Fig. 2).

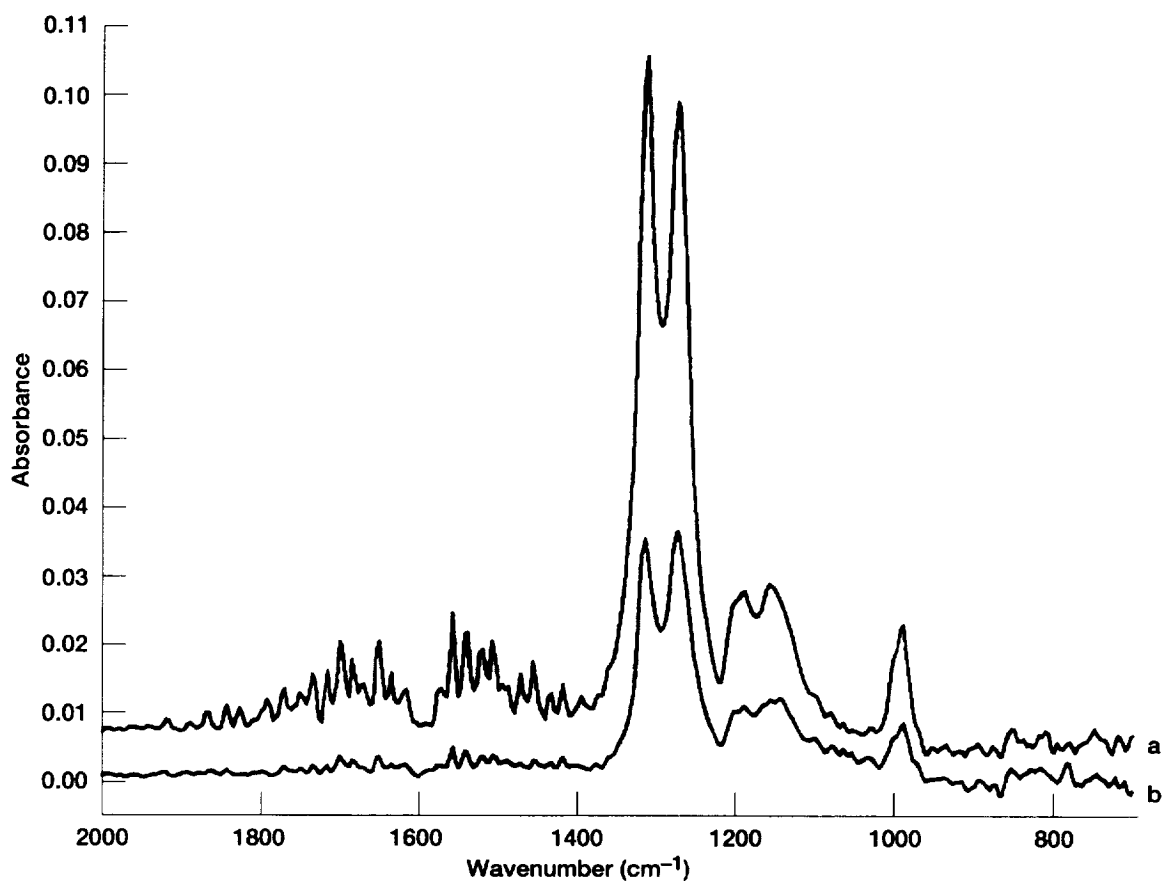
Figure 4.—FTIR spectra of the original film (a) and of a wear track from region I (b).

Typically, infrared analysis of wear tracks in this region indicated no chemical changes, only a thinning of the lubricant layer. This thinning corresponds to about a 40 % decrease in the original film thickness. Lubricant accumulation at the sides of the wear track was not observed. Therefore, the majority of displaced lubricant was transferred to the unlubricated ball. Lubricant thickness in the wear tracks varied from 240 to 400 Å. Figure 4 contains infrared spectra of the original film (a) and of a wear track (b) from Region I.

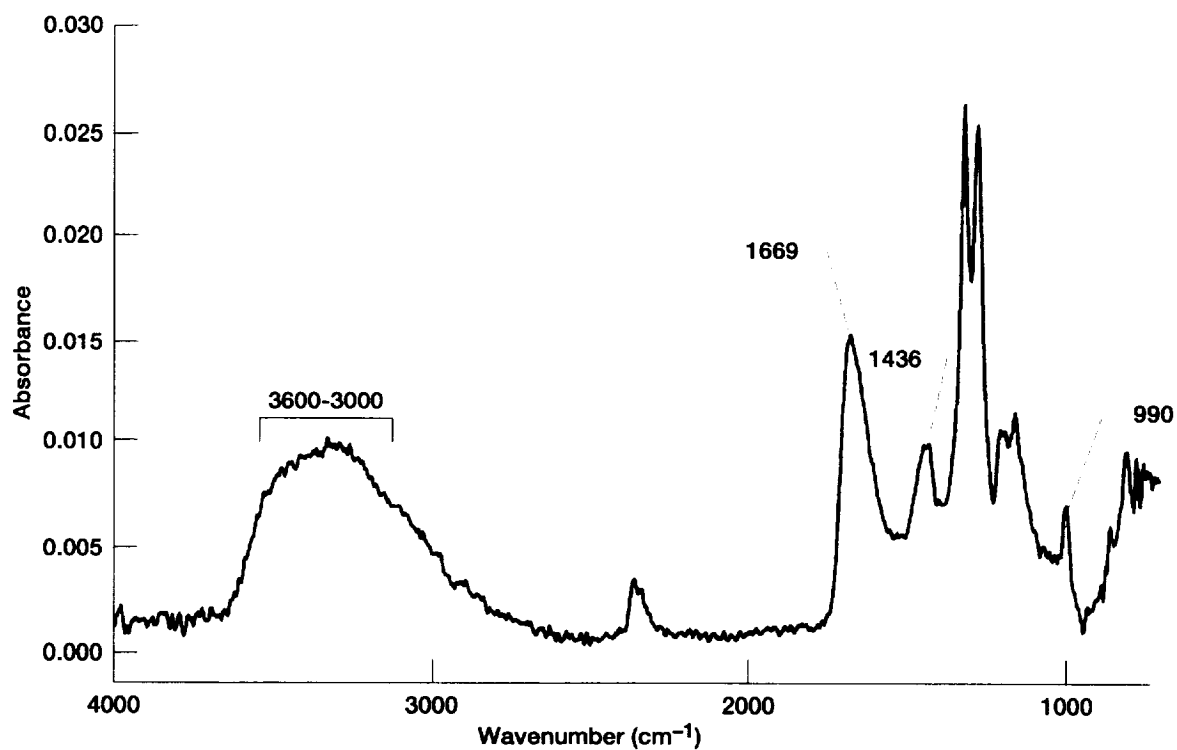
Figure 5.—FTIR spectra of a wear track from region III.

A typical IR spectrum of the wear track in this region appears in Figure 5. This signature is quite different from that of unused lubricant. A brown material was visually observed on the wear track. This brown material yields a broad band at 3000 to 3600 cm^{-1} and another set of bands at 1669 cm^{-1} and 1436 cm^{-1} . The broad band can be assigned to hydrogen bonded hydroxyl groups. The other two bands can be assigned to carboxylic acid species. There are also C-F vibrations from the original lubricant at 990, 1127, 1270 and 1310 cm^{-1} .

The growth of the 3000-3600, 1669 and 1436 cm^{-1} bands simultaneously occurs with the change in appearance of the wear track. When the brownish material is obvious in the wear track, these three bands are easily detected. These bands were present in the wear track after both nitrogen and air runs. Relative abundance was directly related to the original film thickness. Intense bands were present after runs using thicker initial lubricant films.

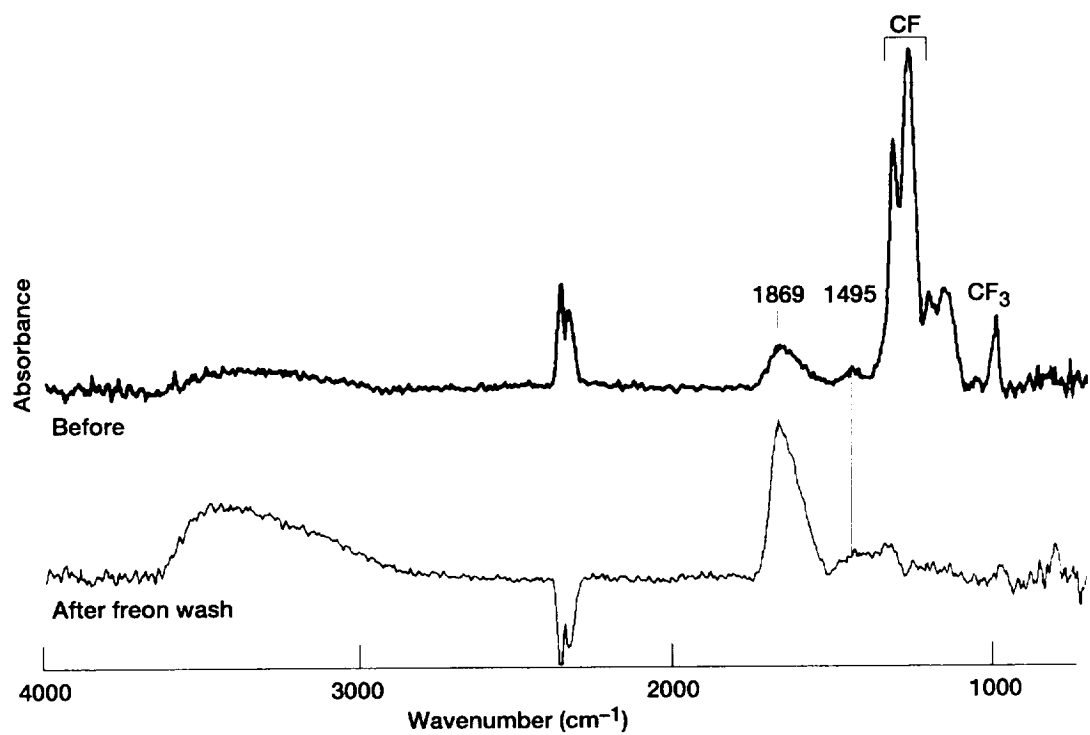
Figure 6.—FTIR spectra of the track surface on the disc before and after rinsing with trichlorotrifluoroethane.

Figure 6 shows the IR spectra of the track surface before and after rinsing with trichlorotrifluoroethane. After rinsing, only the species associated with the carboxylic acid remained. Most of the C-F signal associated with the unaltered PFPE has disappeared.

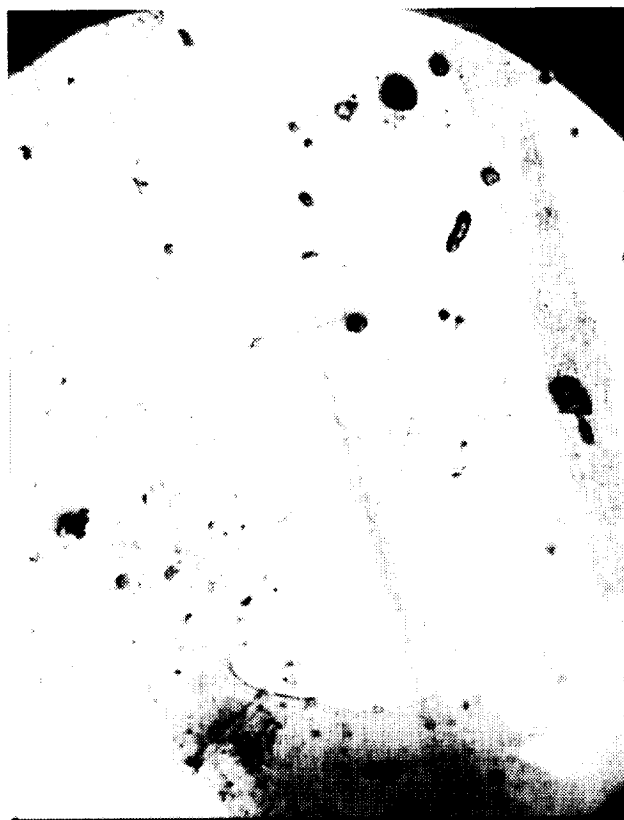
Figure 7.—Typical ball wear scar with accompanying debris.

Ball wear scars were also analyzed. Since the balls were not lubricated prior to testing, all material found on the scar must come from the contact area. The entrance and exit regions of the scar show an accumulation of wear debris and the same brown material found in the wear tracks. This brown material is abundant in these regions. When the apparatus was run with thick lubricant films, this material could be removed and

transferred to a gold coated slide for further examination. A micrograph of a typical ball wear scar with accompanying debris appears in Figure 7. The IR spectrum of the brown material is shown in Figure 8. Like its counterpart on the disc's wear tracks, this transformed material is insoluble in fluorinated solvents or hexane at room temperature and is strongly attached to the surface. Sometimes, there is a build-up of this material in the entrance to the wear scar and along the track. This brown, insoluble material is termed "friction polymer." When a large amount is present, it can be removed and placed on a glass slide for spectral analysis. The Raman analysis of such a sample is described below.

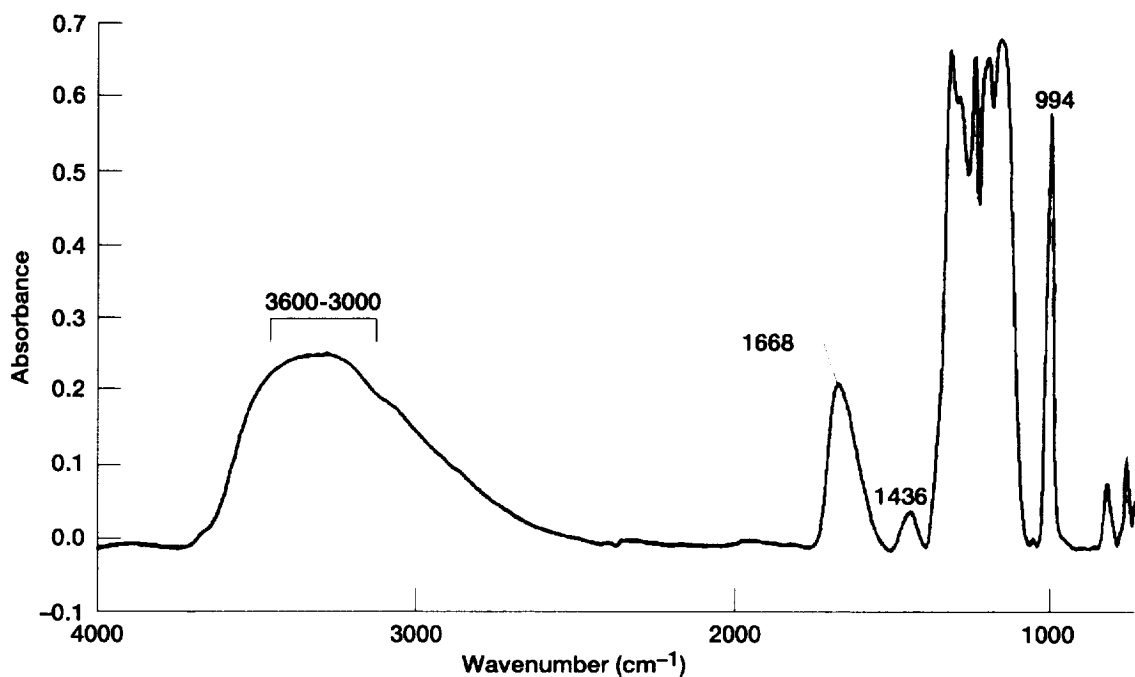
Figure 8.—FTIR spectrum of the brown colored material found on the wear scar.

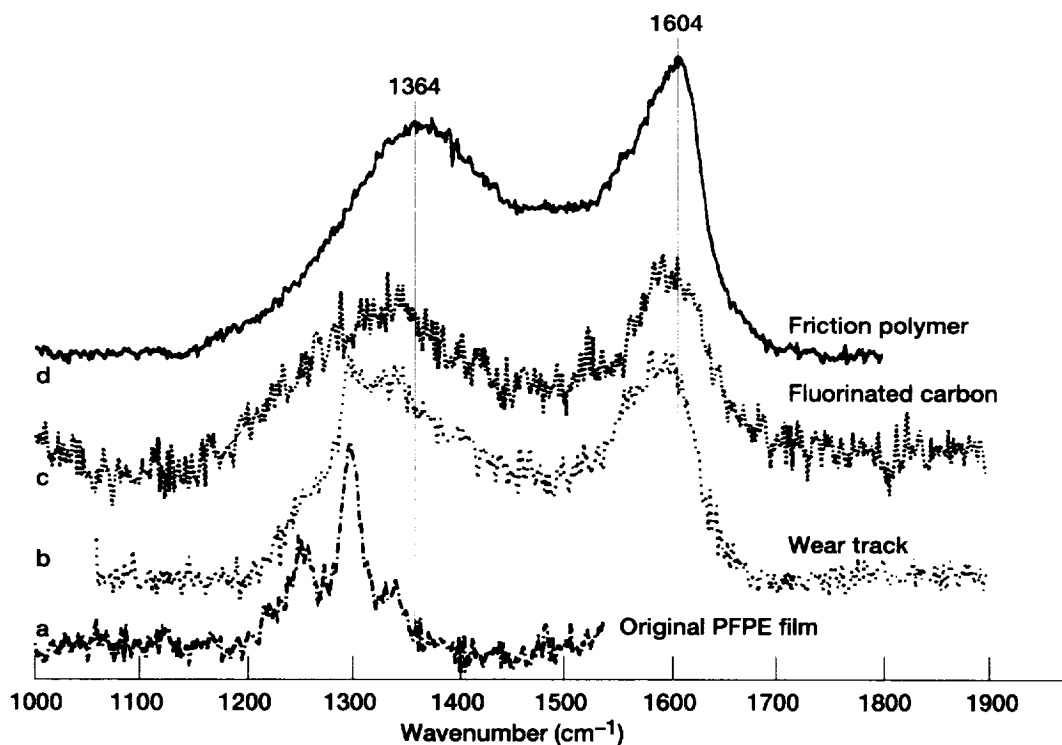
Figure 9.—Raman spectra. (a) 440C surface after PFPE film deposition. (b) Wear track run to failure (region III). (c) Fluorinated amorphous carbon. (d) Tribologically degraded PFPE deposited on a gold slide.

Raman spectra for the region from 1000 to 1900 cm^{-1} of several surfaces appear in Figure 9. A spectrum for the 440C surface after application of the PFPE film is shown in Figure 9a. This is the signature of the carbon sp^3 backbone of the original PFPE. Spectrum 9b was obtained from a wear track run to failure (Region III). For comparison, a spectrum of a commercially available fluorinated amorphous carbon powder appears in Figure 9c. Figure 9d contains the spectrum of tribologically degraded PFPE (friction polymer) removed from a ball (figure 7) and deposited on a gold slide. The peak at 1364 cm^{-1} can be assigned to the so called "D" band. It can be attributed to the scattering by disorder activated optical zone edge phonons of graphite (18) which is due to various orientations of graphitic micro or nanocrystallites. Thus, the "D" band is a direct measure of the order (disorder) of this tribologically created structure. The broad band at 1604 cm^{-1} is the original "G" peak found in highly oriented pyrolytic graphite at

1576 cm^{-1} , previously assigned to scattering by graphitic optic zone center phonons (18). This band shifts and broadens as a result of the change from mostly C sp^3 to C sp^2 bonding. Thus, Figure 9b shows both the broad doublet from the “G” and “D” bands, and the signature of residual, undegraded PFPE lubricant.

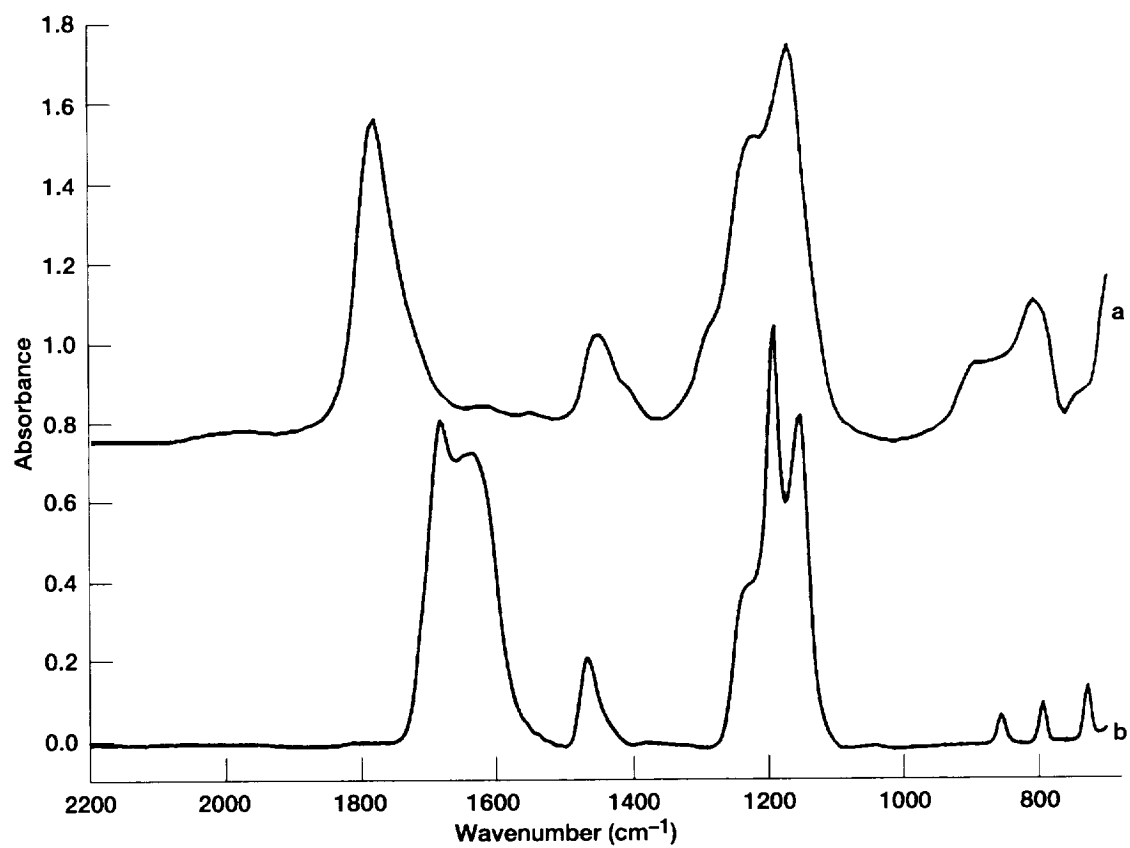
Figure 10.—FTIR spectra of fluoroacetic acid. (a) In transmission. (b) Adsorbed on 440C steel.

For comparison, Figure 10 shows the IR spectra of neat trifluoroacetic acid, both in transmission as well as adsorbed onto a 440C steel disk. The asymmetric carbonyl stretching frequency shifts from 1786 to 1660 cm^{-1} . The symmetric carbonyl stretching band also shifts from 1444 to 1473 cm^{-1} . The adsorbed carboxylate must be hydrogen bonded, as suggested by Liang and Helmick (20), as indicated by the broad band from

3000 to 3500 cm^{-1} . It is well known that hydrogen bonding and conjugation shift the C=O stretching band to lower frequencies.
